TA 01-24 NEDU TR 03 - 08 **April 03**

UNMANNED TEST AND EVALUATION OF THE TELEDYNE ANALYTICAL INSTRUMENTS R-10DN OXYGEN SENSOR FOR USE IN THE MK 16 MOD 1 UNDERWATER BREATHING APPARATUS

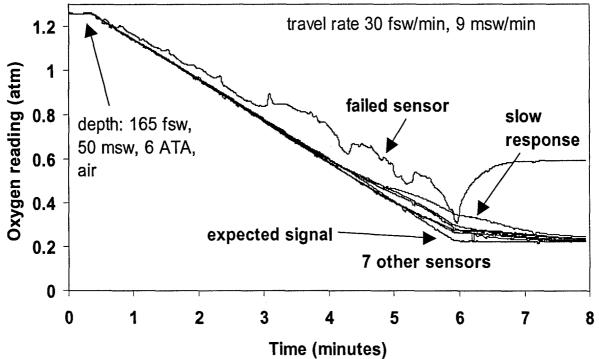
Some sensors behaved in unexpected ways when, during decompression, they produced a sudden large voltage increase to levels that were two to three times greater than the other sensors (Figures 1 and 2). The voltage later returned to expected levels. This recovery took from a few minutes to several hours. Some weeks of (accelerated) life later, such a sensor would typically start to leak a clear liquid that felt slippery. The manufacturer explained that this liquid was potassium hydroxide (KOH), a high-pH liquid that is the electrolyte in the sensor. After such a leak, a sensor produced no signal at

- 1. Responses to simultaneous changes in pressure and PO₂ (Fig 2.) slowed during compression and, at an earlier age, during decompression.
- 2. Sudden large increases in signal during a decompression (Fig. 1) preceded electrolyte leaks.

The sensor lifetime of 27 months is set to be shorter than that at which any of the failures were noted. Some sensors failed by having a slowed response to changes in pressure, the same failure noted in some of the R-10DV sensors. Over a period of time (i.e., from minutes to hours), these slow responses would go away but recurred during the next dive. Other sensors failed by showing a drastic increase in signal during decompression. A MK 16 diver can notice these impending failures by watching the readings on the secondary display. If one sensor seems to respond to O_2 pressure changes more slowly than the others do, such sluggishness may signal an impending failure. Similarly, if one sensor shows unreasonably high values during decompression or after a dive, it may be about to fail or may be considered to have failed already.

Figure 1. Observed failures of other sensors. The lowest line is a recording of a normally functioning sensor. The red line shows the erratic behavior of a failed sensor. The lines between, at about 6 minutes, show the slow response to changes in oxygen pressure caused by changes in absolute pressure.

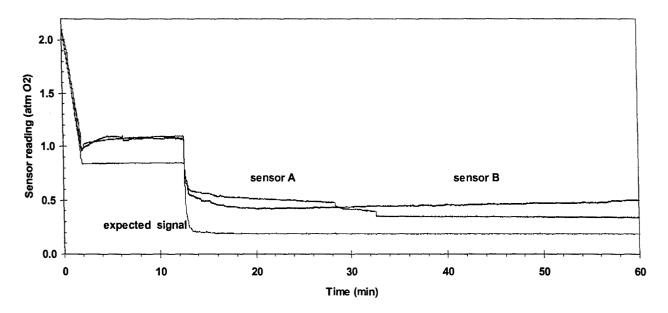
A first batch of 20 sensors was started with all the tests performed on them. Towards the end of their expected lifetimes, some the sensors behaved the same as the previously approved R-10DV O₂ sensors had: they were slow in providing the expected voltage after a change in the chamber pressure (Figure 1). This became evident both during compression and decompression but was noted earlier in the testing during decompression. However, the voltage did reach the expected value after a few minutes. Even after such changes were noted, response times did not change.

Figure 2. Observed failure of two sensors during a decompression from 300 fsw with air. The bottom line is a recording of a normally functioning sensor. See text for a discussion of the failure modes for sensors A and B.

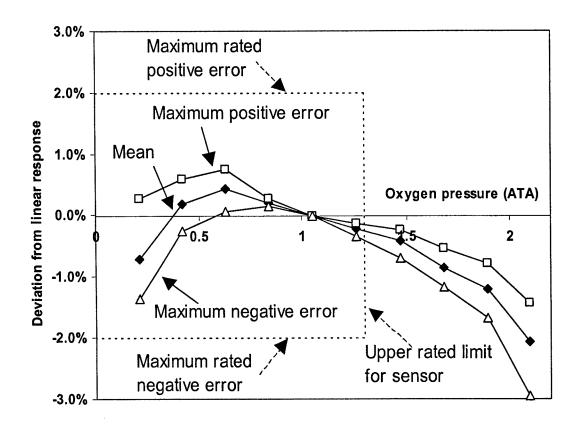
The average deviations from linear response during one test are illustrated in Figure 3. The average error within the manufacturer's specified range (0 to 1.3 ATA) was -0.01%, and the greatest error in any sensor was 1.4%. Even at O_2 pressures as high as 1.9 atm the mean errors were within the manufacturer's limit of $\pm 2\%$.

Figure 3. Average and maximum deviations from a linear response for 20 sensors (about 10 months old) tested with air. The reading at 1.05 ATA was set to be the calibration point for each sensor. This was as close as possible to the calibration procedure for the MK 16. The dotted line shows the range specified by the manufacturer ($\pm 2\%$ error, max 1.3 ATA O₂).

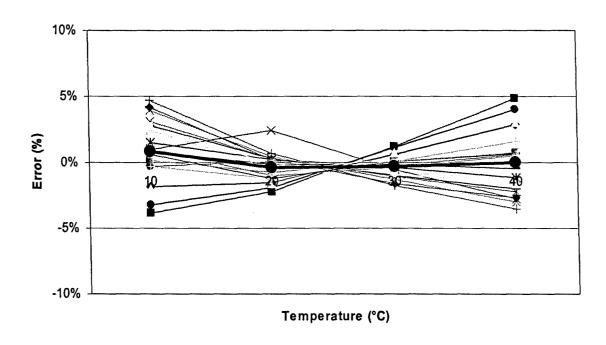
Temperature changes increased output voltages for some sensors, while for others those voltages decreased (Fig. 4). For each sensor, output voltages were averaged for all temperatures, and deviations from the average were then calculated. The average deviations due to temperature changes are well within specifications (Table 2). The greatest individual deviations were just outside specifications and occurred in the same two sensors at both ends of the temperature range. At these temperatures, the two sensors were sometimes outside, sometimes inside the specifications.

The majority of the sensors showed temperature changes that were within the manufacturer's specifications. Two sensors were marginal in their sensitivity to temperature changes, sometimes being just beyond and sometimes within specifications at the extreme temperatures.

Figure 4. Changes in sensor outputs based on ambient temperature changes. Each thin line represent a sensor, while the thick black line shows the mean for all 20 sensors.

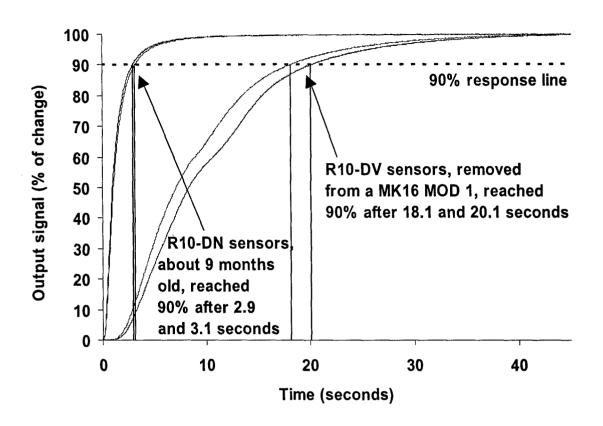
The measured response times to 90% of change varied from 2.5 to 3.8 seconds when the O_2 both increased (Fig. 5) and decreased.

Figure 5. Change in output signal when the sensor was exposed to a change from air to $100\% O_2$. The responses of two R-10DN and two currently approved R-10DV sensors are shown.

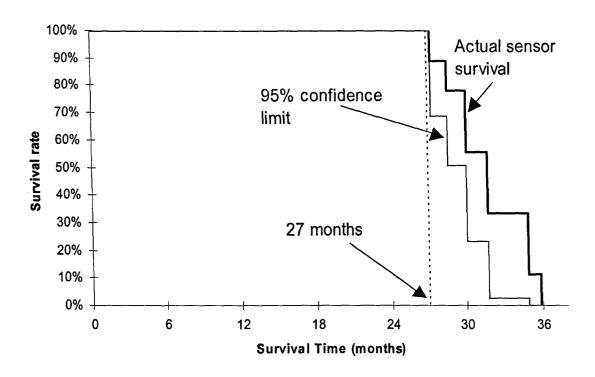
The survival rate is illustrated in Figure 6. All sensors survived at least 27 months. The Kaplan-Meyer survival analysis indicated a lower 95% confidence limit of 27 months.

Figure 6. Actual sensor survival rate and the lower 95% confidence limit for R-10DN oxygen sensors.

The R-10DN sensors are essentially within the manufacturer's specifications. Since these specifications are the same or better than those for the currently approved R-10DV sensor, we recommend that the R-10DN sensors be approved for use in the MK 16 MOD 0 and MOD 1 for a service life of 27 months.
